MMT BRIEF

Typhoon Soudelor Impacts: *Sea Touch* Debris; Preliminary Assessment of Damages to Seagrass Habitat

BECQ Marine Monitoring Program

14 September 2015

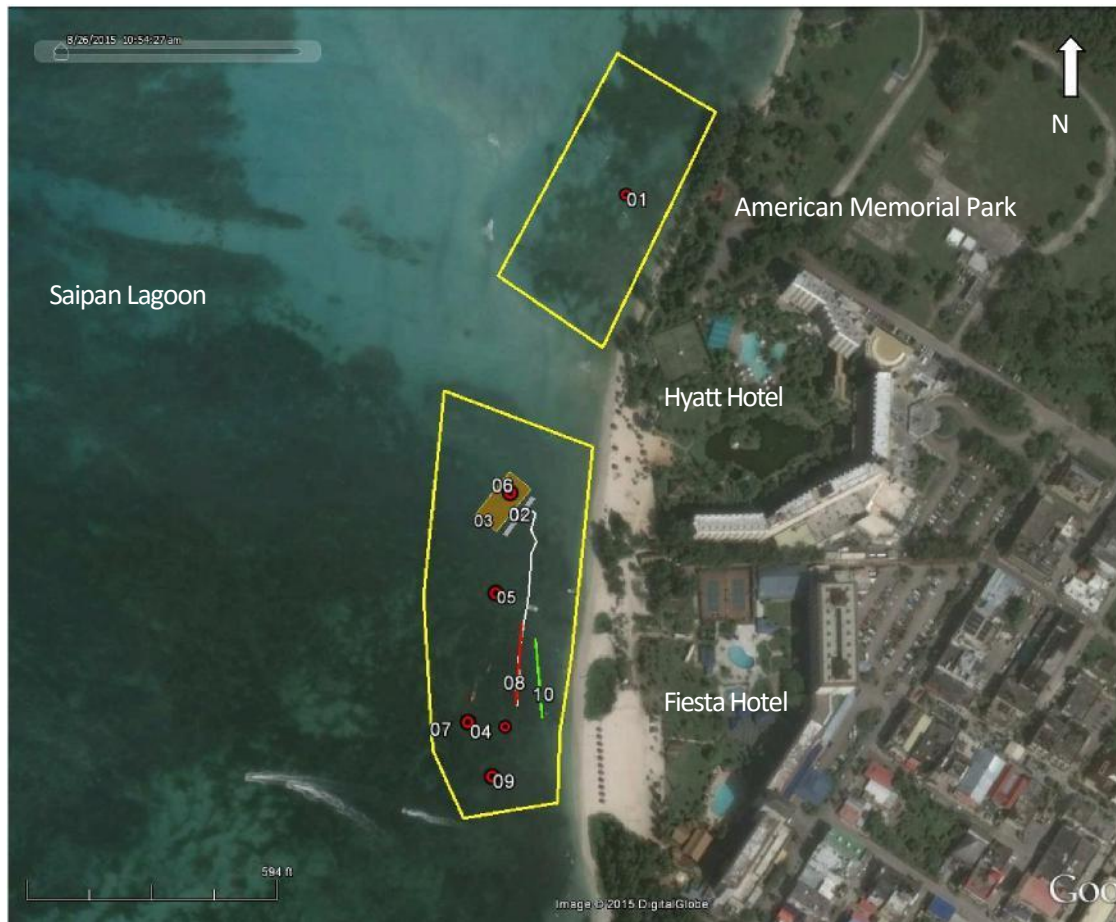
Although the floating pontoons had been removed and secured on land by the second survey on August 24, 2015, a large amount of subsurface debris remained in the marine environment, continuing to affect the seagrass habitat and associated marine life. Debris included large concrete poles, concrete block anchors, chains, various pieces of hardware, and chain-link fencing, including a large section measuring 35 m x 1.5 m (Fig. 1).

Figure 1 Map of impacted seagrass habitat (yellow boundaries), a representative *subset* of observed debris and environmental damages, and impacted (red line) and reference (green) transects. 01: final location of large sections of floating walkway, anchors, chains, and fencing; 02: large section of chain link fence (35 m x 1.5 m); 03: series of linear scars (orange box); 04: large pile of debris; 05: concrete pole anchor and beginning of linear scar; 06: concrete block anchor; 07: debris surrounded by seagrass scars; 08: surveyed impact transect (red line) within large linear seagrass scar (white line); 09: concrete anchors; 10: non-impacted reference transect (green line). Note: these points are merely a representative subset of the debris and damages observed, not a complete inventory.

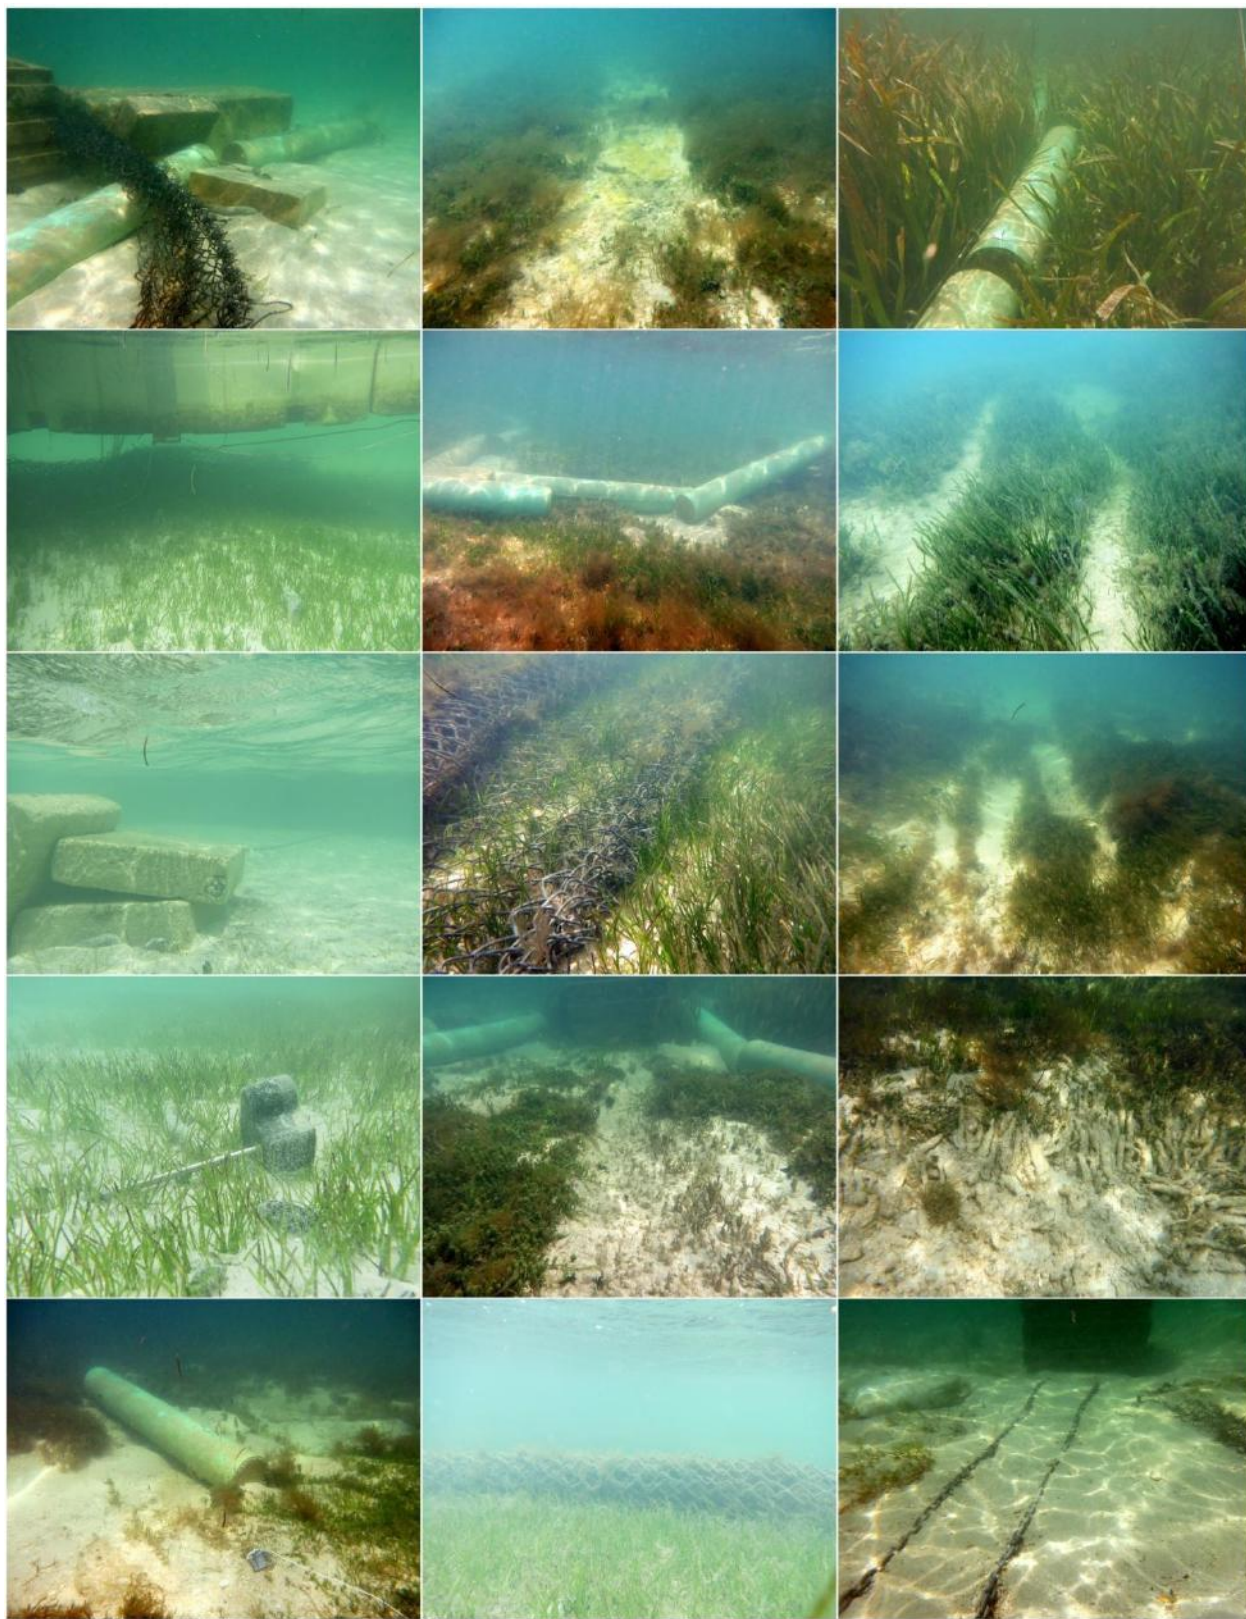
Figure 2 Representative photographs of debris and environmental damages caused by the destruction of the Sea Touch facility during Typhoon Soudelor.

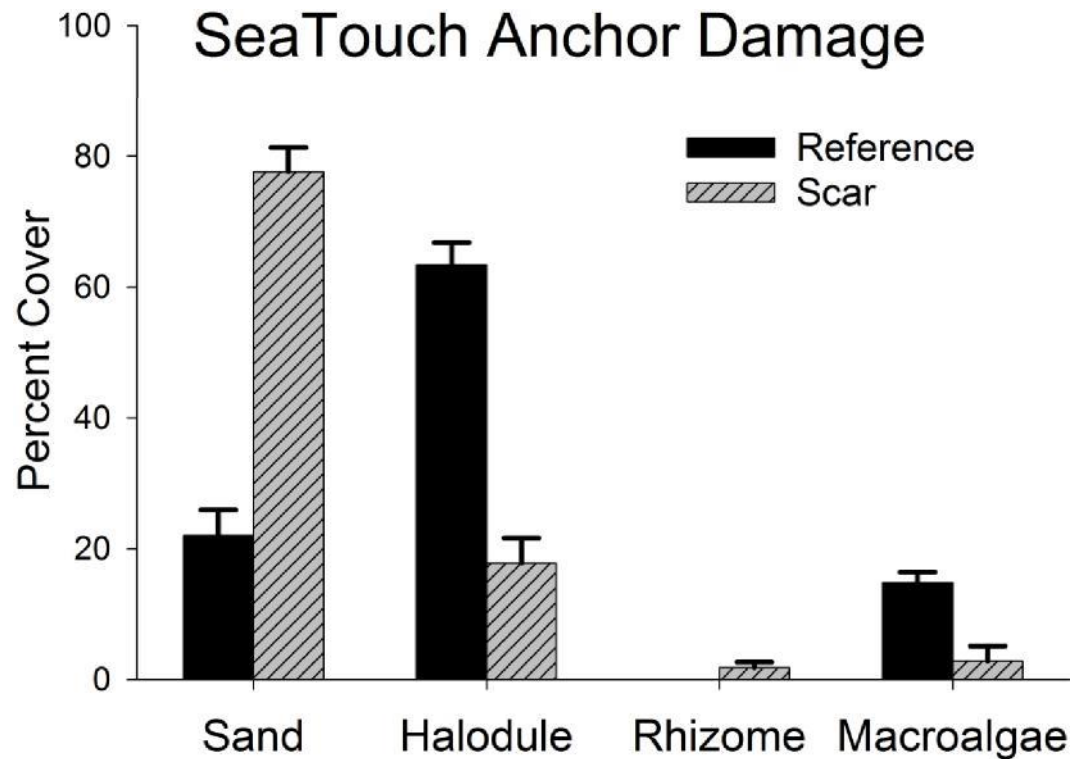
The habitat impacted was a mixed seagrass/macroalgae meadow dominated by the seagrass species *Halodule uninervis*, interspersed with patches of sand. The quality or integrity of seagrass habitat is often assessed using the ratio of seagrass to macroalgae cover as high macroalgae cover is indicative of poor water quality (Houk and Camacho, 2010). Part of the area impacted by the Sea Touch facility was high quality seagrass habitat as indicated by the high average seagrass to macroalgae ratio of the surveyed reference (non-impacted) transects (4.3:1). Many scars were observed in the seagrass and macroalgae habitat across the area surveyed, ranging in length from 1 m – 145 m. Scars were characterized as denuded areas where damaged seagrass blades and seagrass rhizomes and macroalgae holdfast which had been ripped up from the substrate, were visible. Not surprisingly, our results showed that the surveyed scar had significantly more sand and significantly less seagrass and macroalgae than the reference area (Fig. 3).

Figure 3 Benthic percent cover (mean \pm SE) of major constituents in Reference and impacted (Scar) survey transects (n = 5 each). Paired t-tests were carried out to test for differences in mean percent cover for each major category; *p < 0.01.

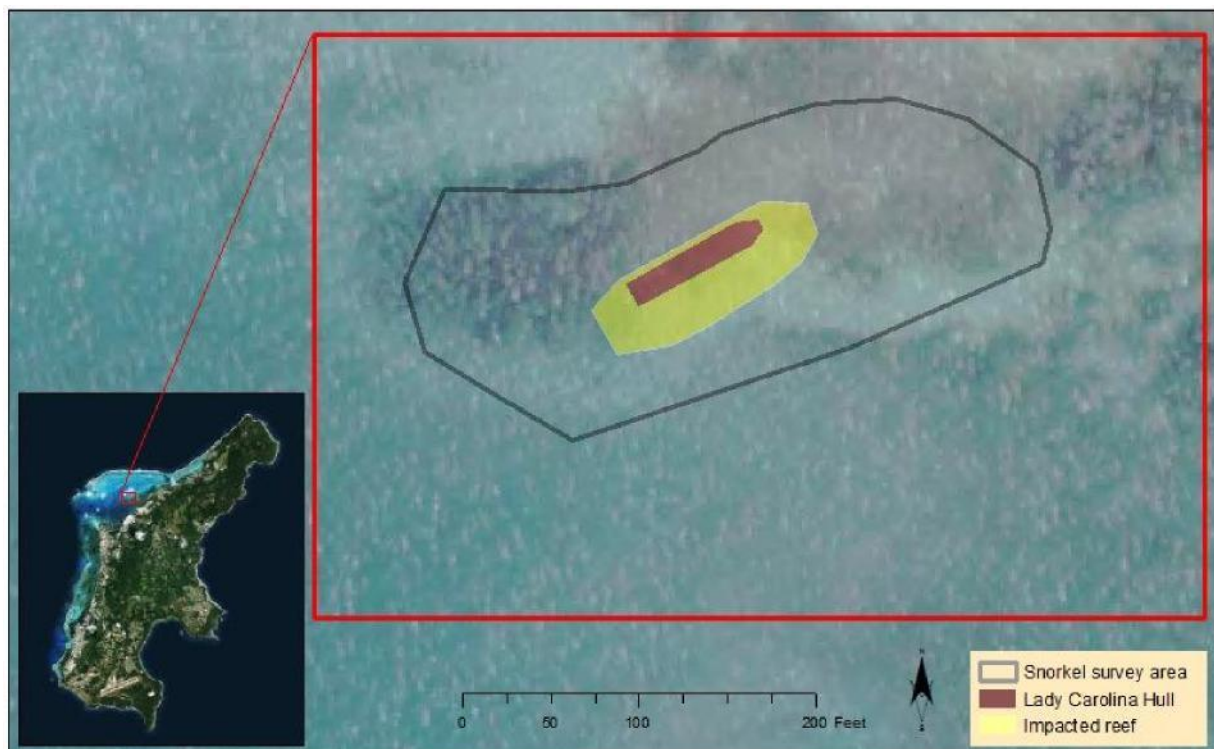
Figure 1. Map of the grounding site and impact areas

On August 2, 2015, Typhoon Soudelor passed directly over Saipan with sustained winds of approximately 127 mph and gusts to at least 150 mph, resulting in severe and widespread damages across the island. During the storm, the fishing vessel *Lady Carolina* broke free of its mooring at Smiling Cove Marina and was blown into the Saipan Lagoon, where it ran hard aground on inshore patch reef habitat (Fig. 1).

Approximately 560 m² of mid-lagoon patch reef habitat has been impacted by the grounding incident (Fig. 1). Damages to natural resources include crushed, fractured, and scraped corals and coral reef habitat (Fig. 2). Several large *Porites* spp. coral heads were dislodged, overturned, and fractured (Fig. 2). Small piece of rusted metal and paint from the hull were also observed on the substrate (Fig. 2).

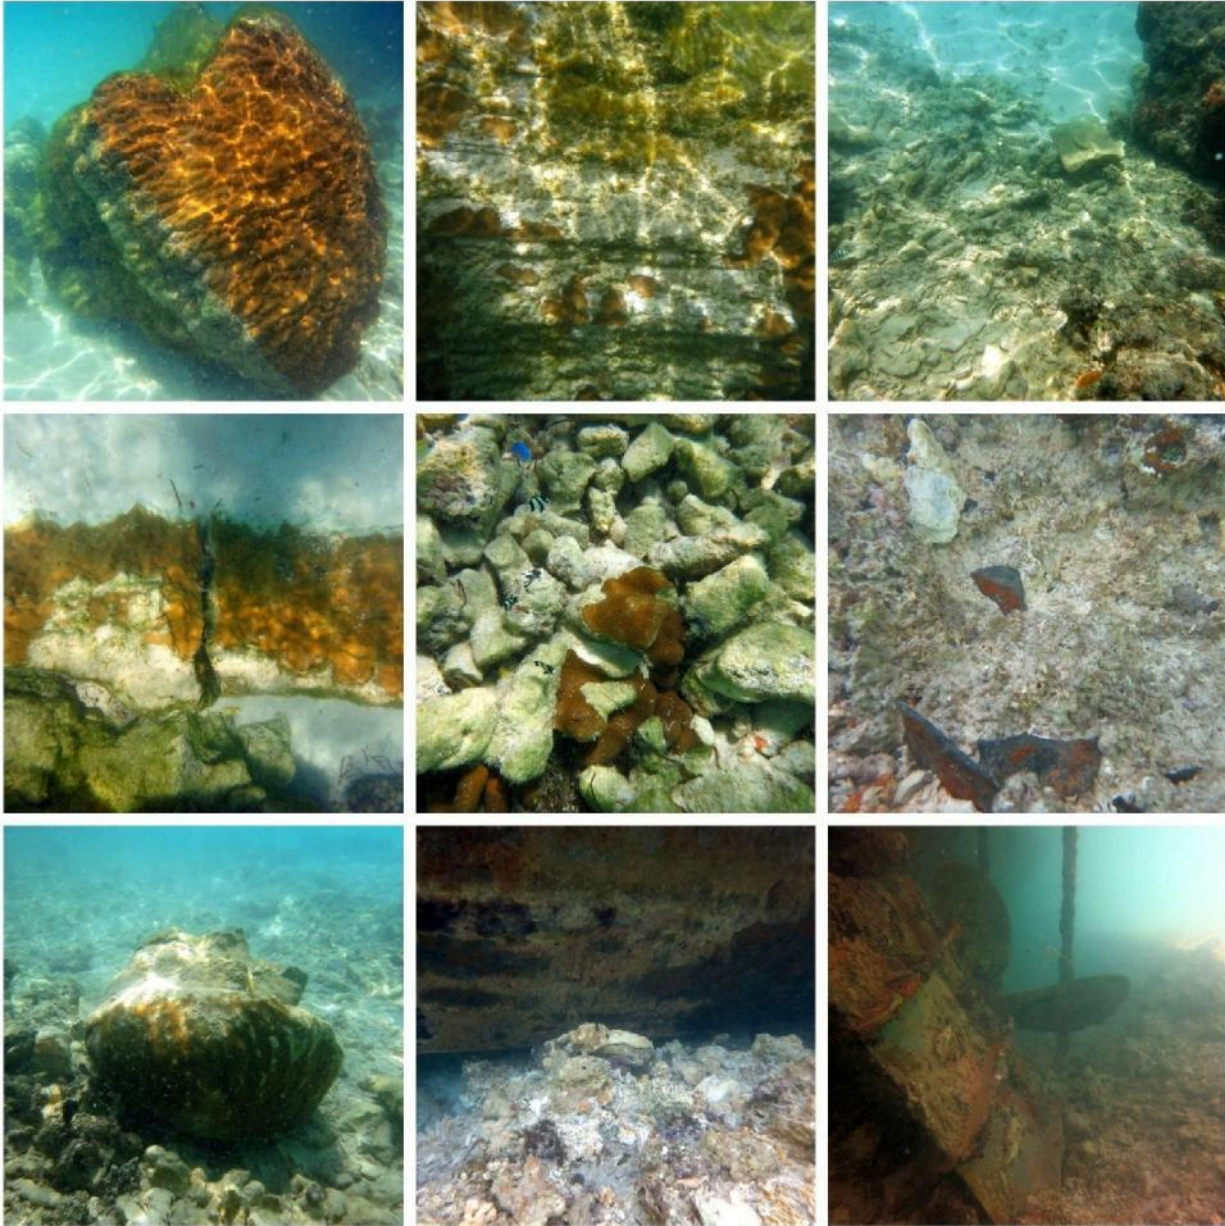
Figure 2. Examples of damages incurred by corals and reef habitat as a result of the F/V *Lady Carolina* vessel grounding in the Saipan Lagoon.
